Plainwell No. 2 Dam Area Time-Critical Removal Action

Weekly Construction Update

Progress Report #12—November 2, 2009

Work Completed: October 22 – October 28, 2009

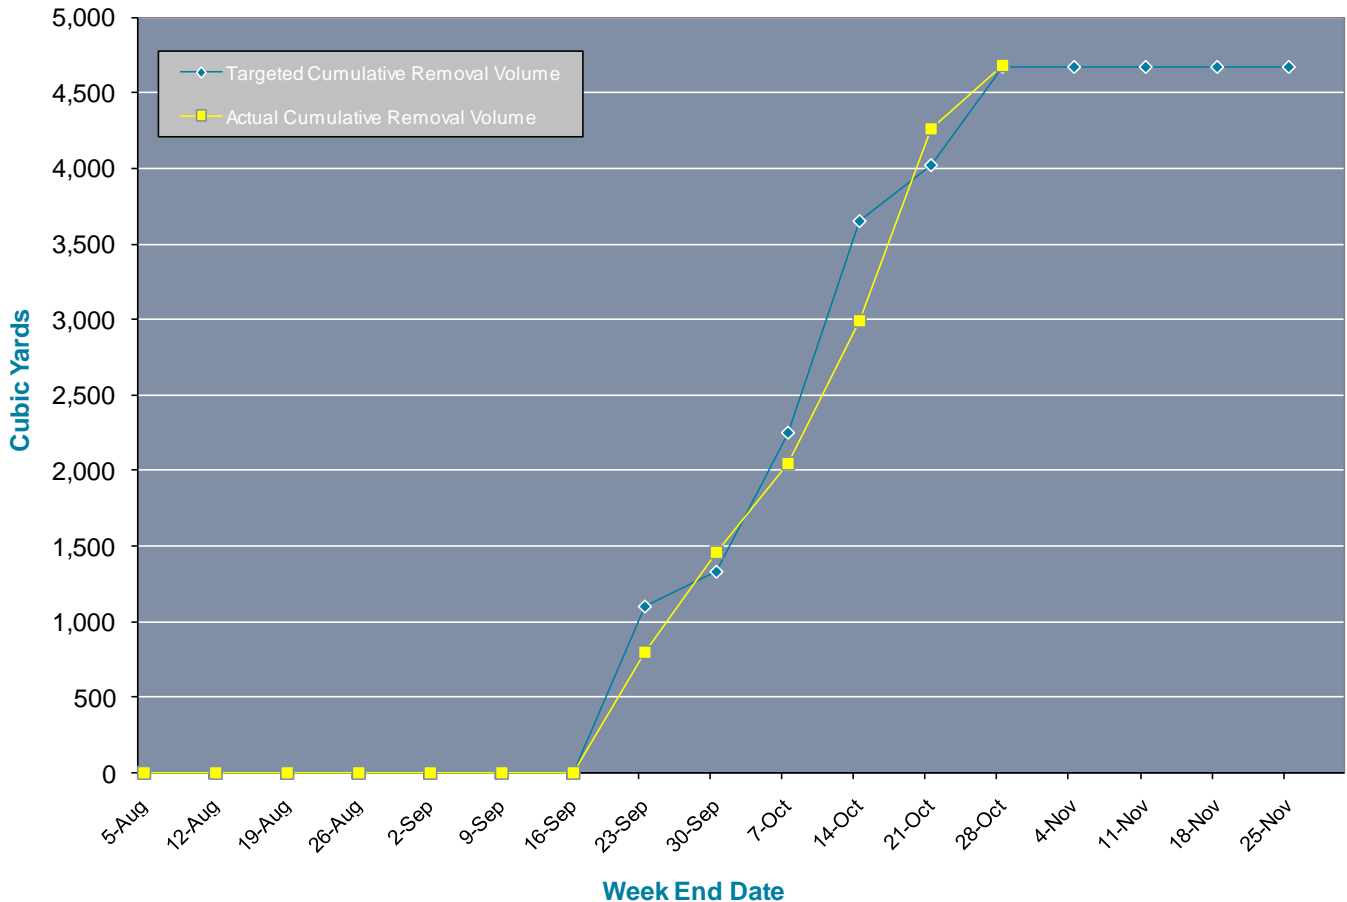
Removal Progress – 2009

Targeted volumes are neat and subject to change due to additional excavation done at request of USEPA.

Actual volumes removed below the targeted volumes potentially due to the conservative estimation methodology used to develop targeted figures and due to the actual topographic conditions encountered at the site, which could result in smaller volumes needing to be removed than originally estimated. The targeted volumes have been increased by 10% to account for additional material that could be removed as a result of over-excavation and additional removal in response to confirmation sampling.

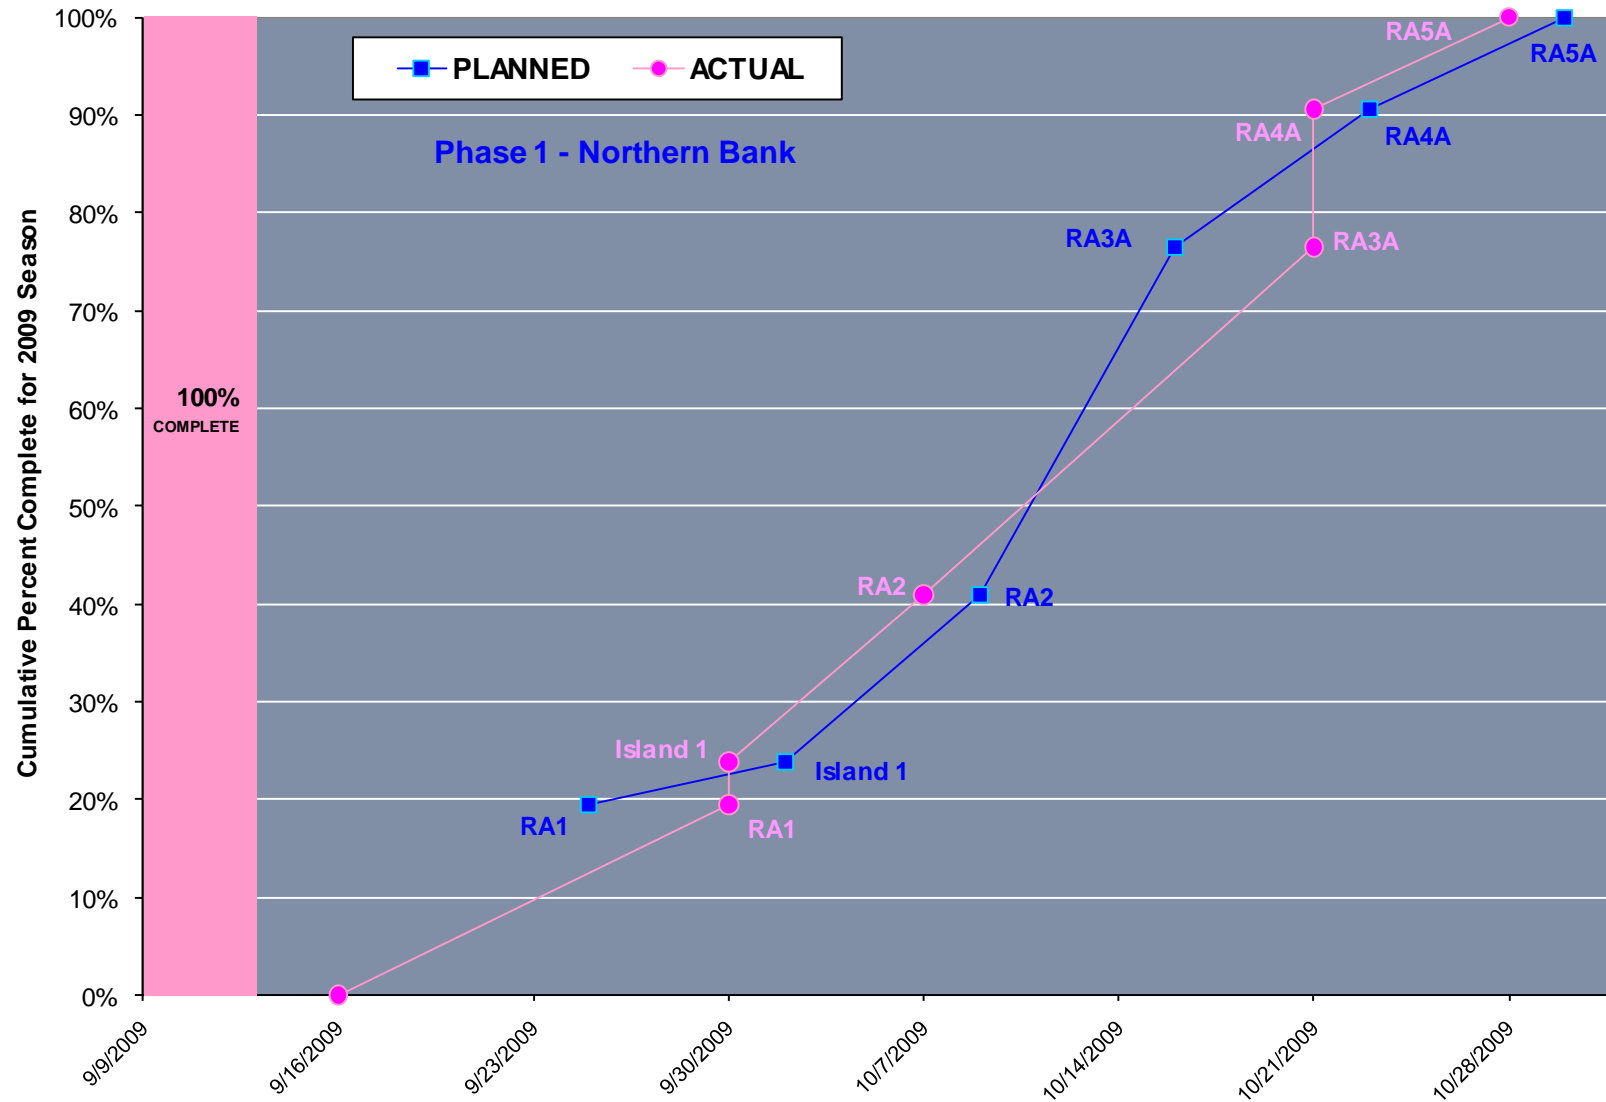
Removal Progress – 2009

For Areas where removal is less than 100% complete, the data point shown is an estimate based on area and volume considerations.

'Complete' is defined as removal of all targeted materials as detailed in the Plainwell No. 2 Dam Area Design Report.

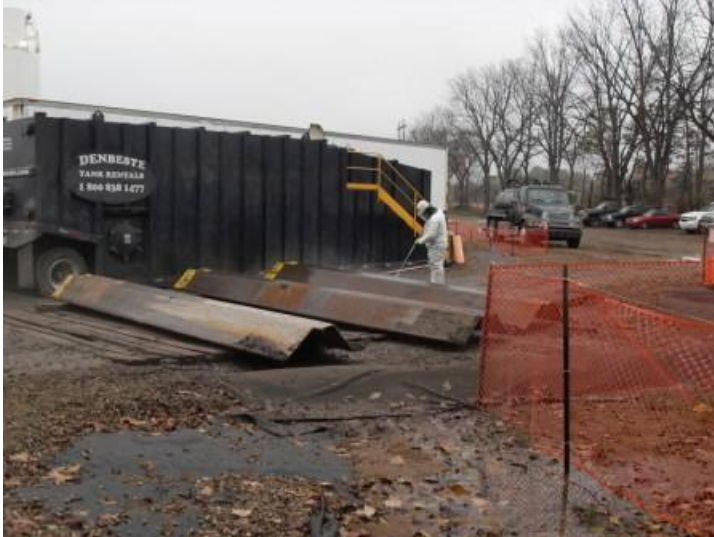
Decontaminating steel sheeting at Staging Area 3.

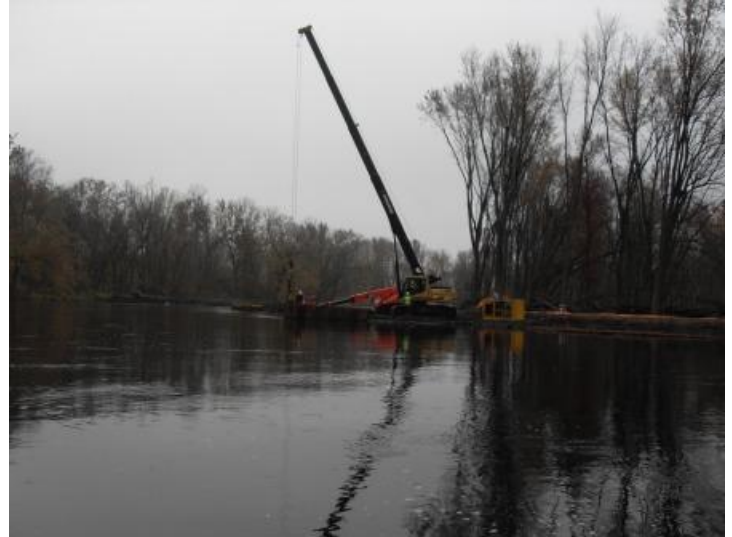
Removing steel sheeting in Removal Area 3.

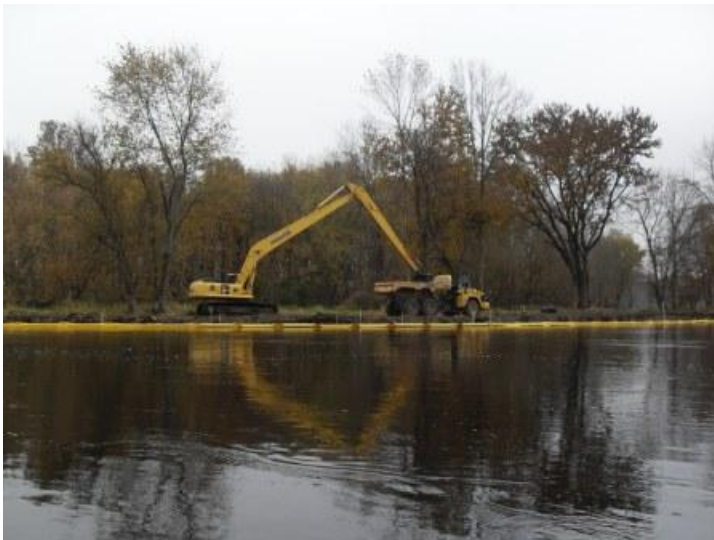
Excavating material in Removal Area 5A.

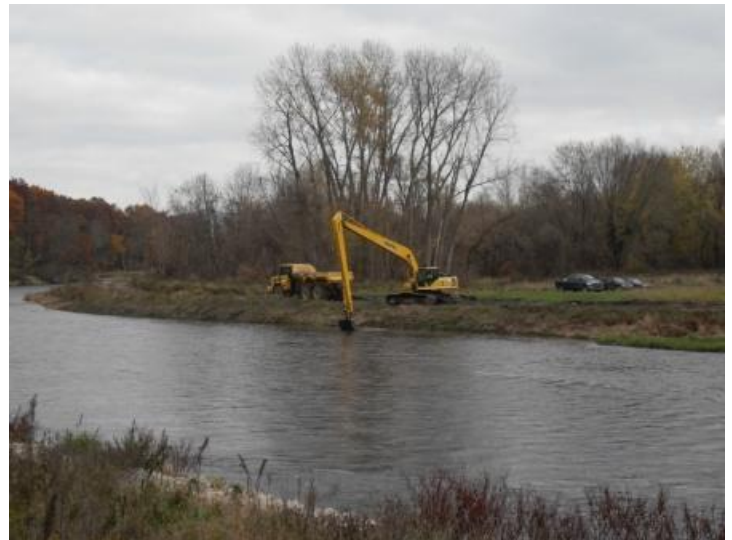
Installing restoration stone in the former Plainwell Impoundment TCRA project area.
